Reliability and Maintainability Evaluation of the Mode S System

Arthur R. Moss
George C. Apostolakis

Prepared By
FAA Technical Center
Atlantic City Airport, N.J. 08405

May 1982

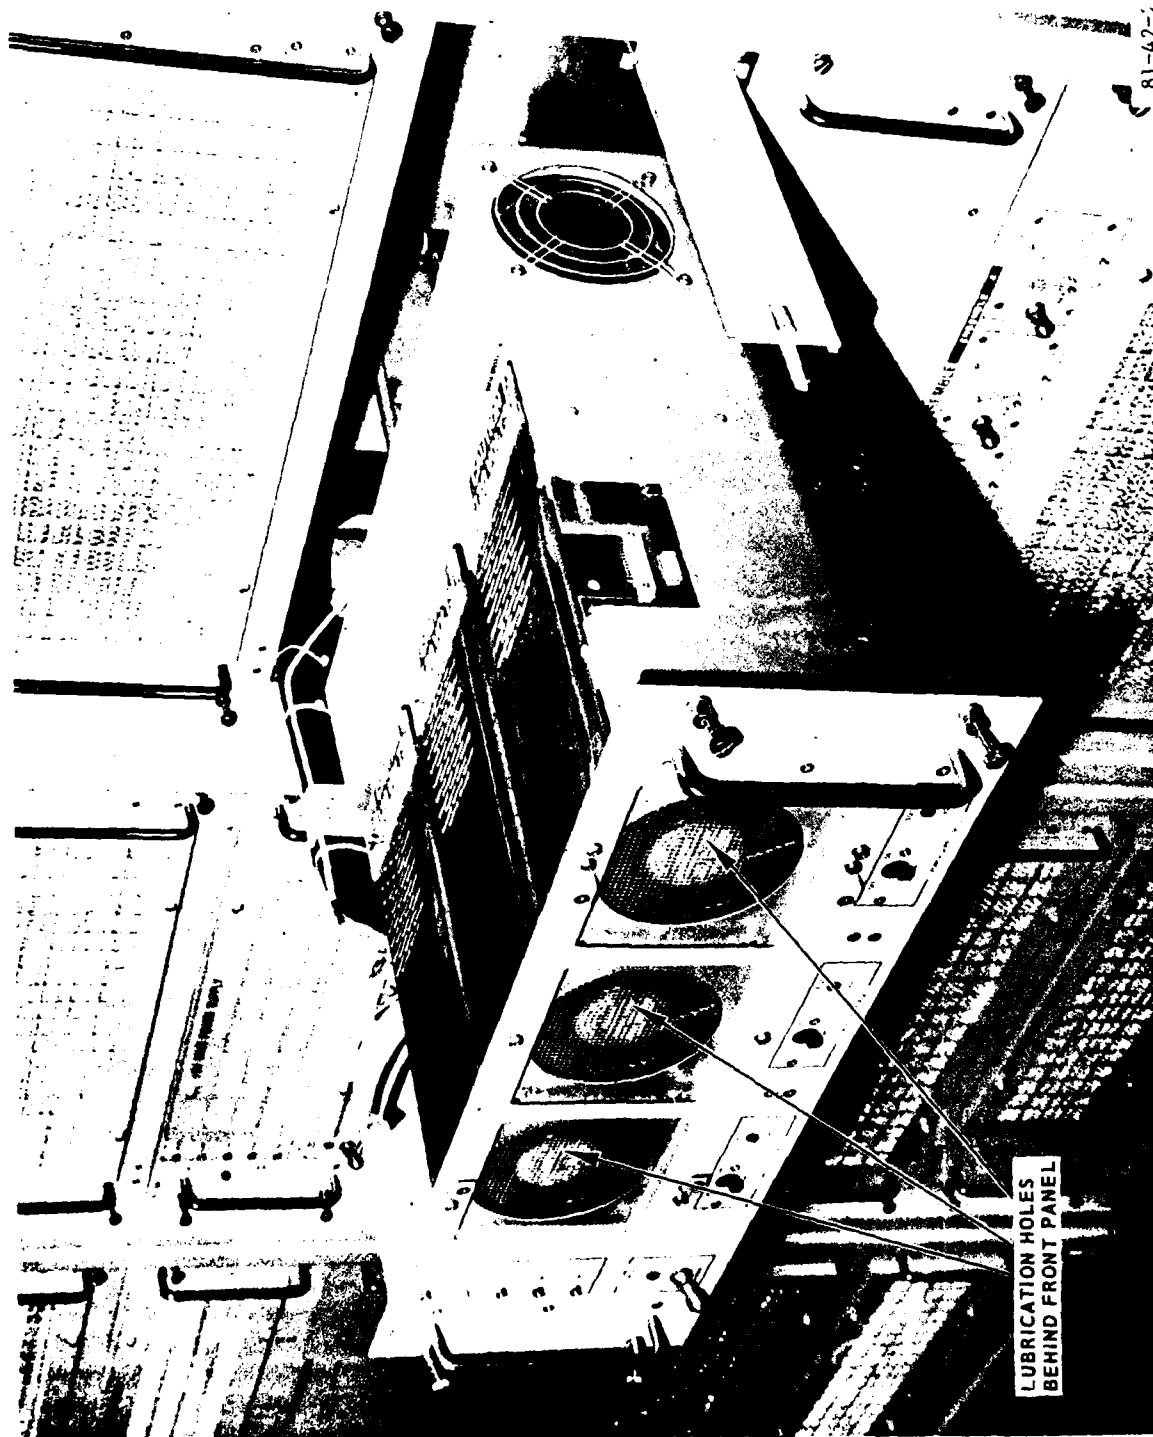
FIGURE 2. TRIPLEX POWER SUPPLY COOLING FANS

COOLING FAN PROBLEMS. Cooling fan failures occurred in the bus lines and the 5-volt triplex power supplies. Of the 12 chargeable bus line failures, 9 involved defective cooling fans. Of the 8 chargeable triplex power supply failures, 5 involved defective Boxer fans. This type of fan has an enclosed oil wick for lubricating purposes. These wicks run dry and are difficult to relubricate because of their inaccessibility. (Figure 2 illustrates this inaccessibility.) Consequently, the fans fail. The lubricating hole is in back of the fan, away from the front panel of the triplex drawer. To gain accessibility, it is necessary to remove the module from the triplex drawer and then disassemble the module to remove the fan.
